**G3432.02-113-11-R1**  
**ACOUSTICAL PERFORMANCE TEST REPORT**  
**ASTM E 90 AND ASTM E 492**

**Series/Model: Distressed Natural Fossilized® Bamboo with Cali Complete™**

**Specimen Type: 152 mm Concrete Slab with Drop Ceiling**

**STC     63**  
**IIC     67**

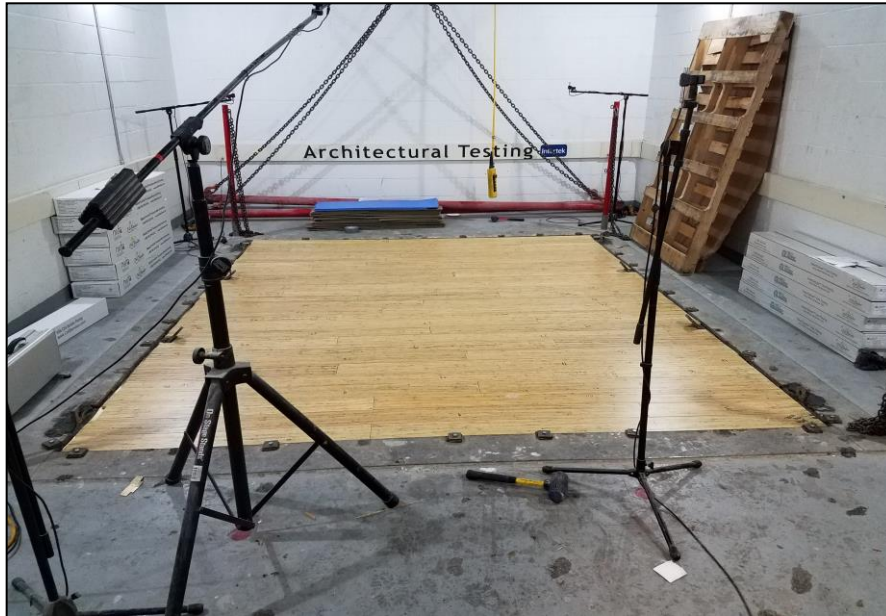
**Source Room View of Test Specimen Installation**

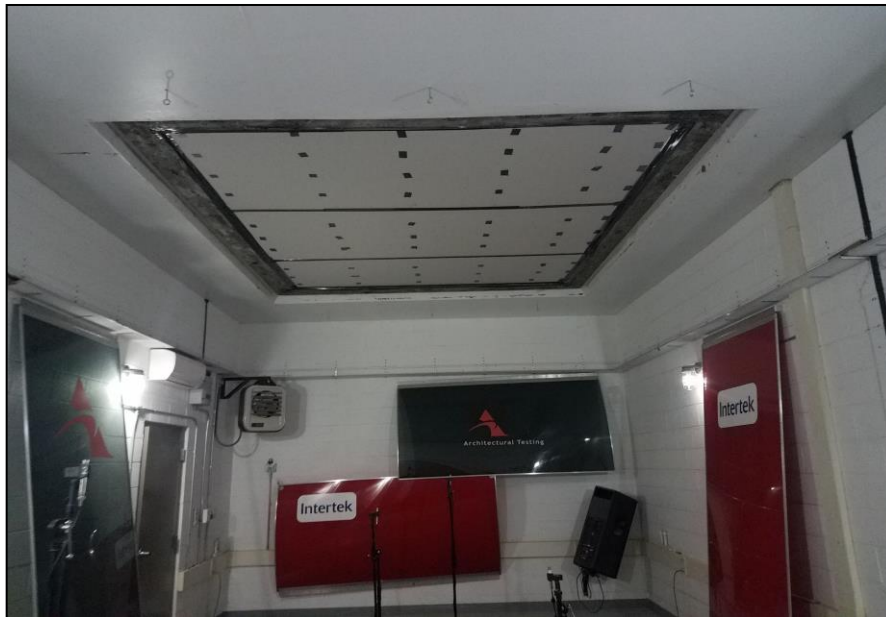
**Receive Room View of Test Specimen Installation**
